Replace Seat Belt Tensioners After Deployment

ServiceNews

BSN 22401 (0101)

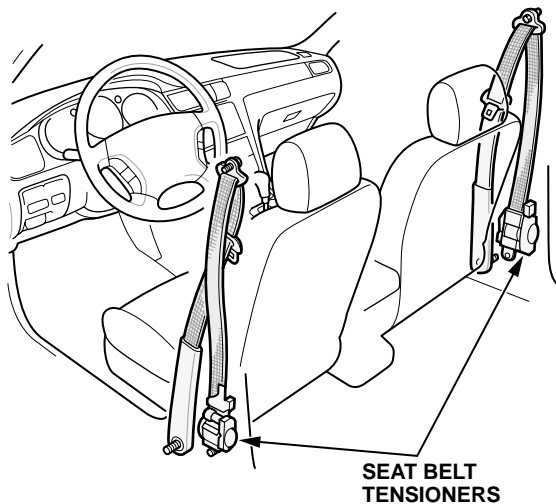
On '01 MDXs, '96-01 3.5RLs, '01 3.2TLs, '01 3.2CLs, '91-95 Legends and '93-01 NSXs, the driver's and front passengers seat belt tensioners are controlled by the SRS unit and are activated when the airbags deploy. In a front-end collision, the tensioners instantly and firmly retract the seat belts to hold occupants in their seats. After airbag deployment, you **must replace** the seat belt tensioners, along with the SRS unit and the deployed airbags.
